Newsletter of The Clay Research Group

Monthly Bulletin of The Clay Research Group

July 2006.

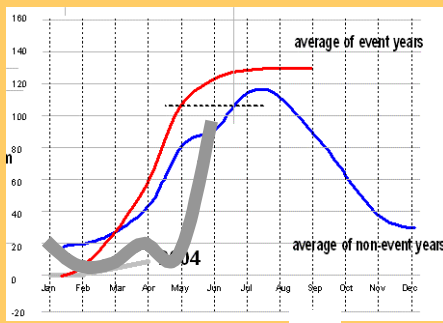
The prediction using statistical techniques suggests 2006 will not be an event year, although it is hard to believe given the recent temperatures and humidity. We are studying the slope of the line against absolute values to further refine the model as necessary

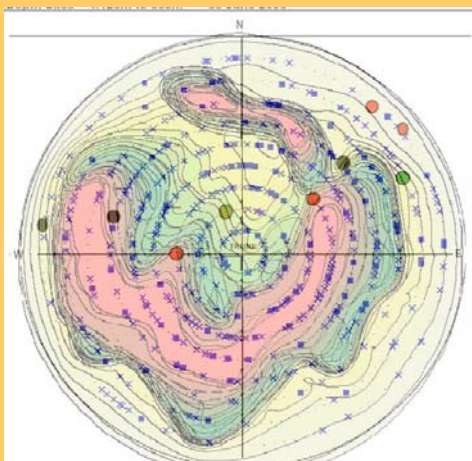
As we gather data we hope to see correlations between the various datasets and here we have superimposed Jon's root radar image onto an earlier ERT simulation to show what we are aiming to achieve.

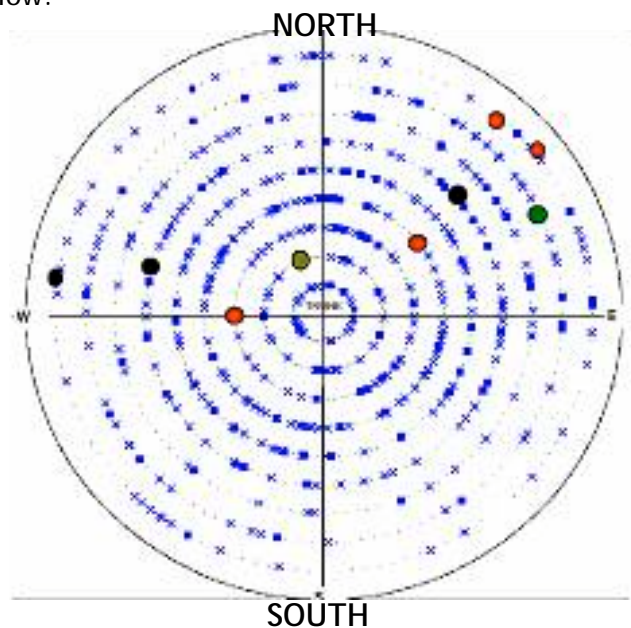
Jon Heuch of Duramen Consulting visited the site in June, to image the root system using radar. The assessment will be invaluable in correlating ERT values with ground movement with the presence (or absence) of roots. His initial scan is reproduced below.

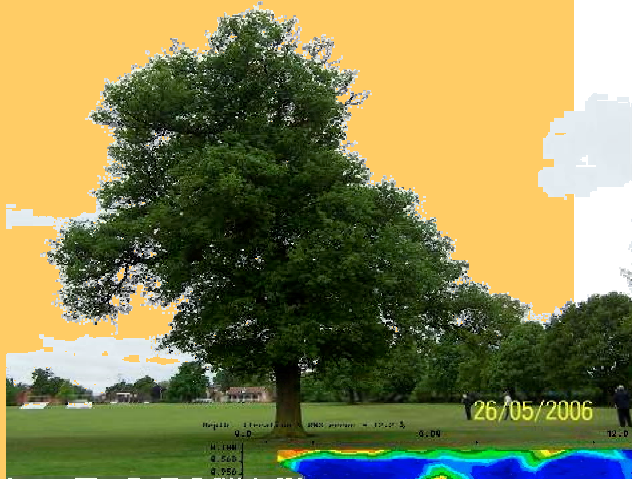
Preliminary Correlation

We have superimposed the precise level readings onto the ERT image to see how the two techniques compare and we see that ground has subsided in the vicinity of maximum drying in two locations.

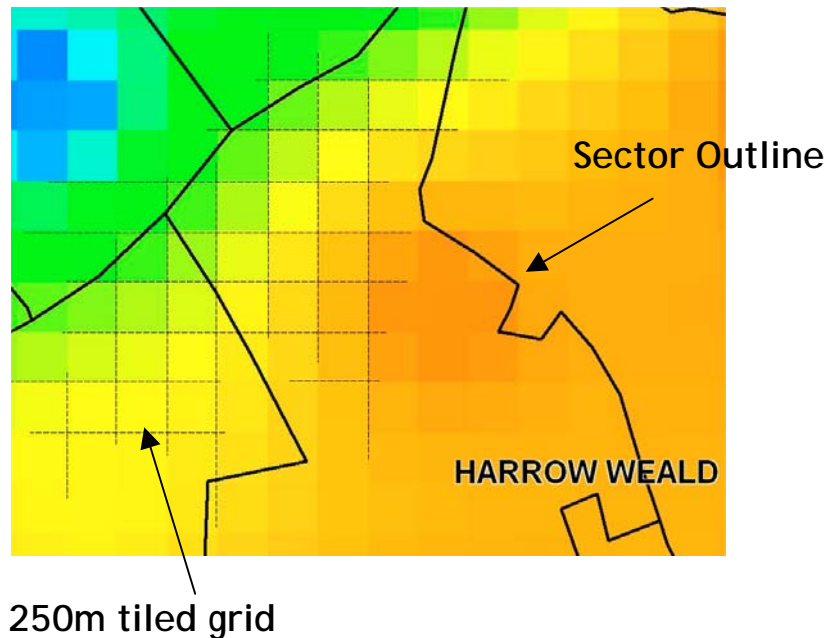
Risk Mapping

We have developed an entirely new geology for Addressology which further refines their understanding of risk. The coloured image shows the shrink/swell properties of the underlying clay, and we have produced a 250m square tiled grid superimposed onto the more traditional postcode sector outlines (bold) to show the benefit.

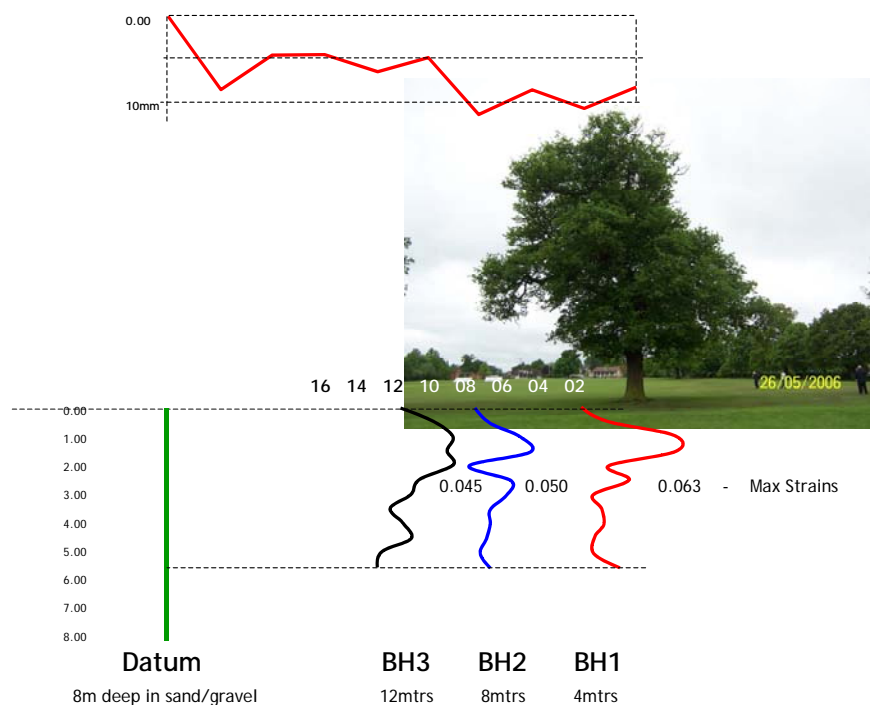
BOREHOLES

Soils testing has produced some interesting data. BH1 (red line) is driest, and is closest to the tree and boreholes 2 and 3 are further away, at 8m and 12m respectively.

The datum (vertical green line) is well clear and has been sunk 8mtrs into a gravel band of Bracklesham Beds. No soil testing here given the granular nature of the soil, and this also acts as the datum for the precise levels.

The precise levels are shown at the top of the picture and the ground sinks as it gets nearer the tree as we would expect.

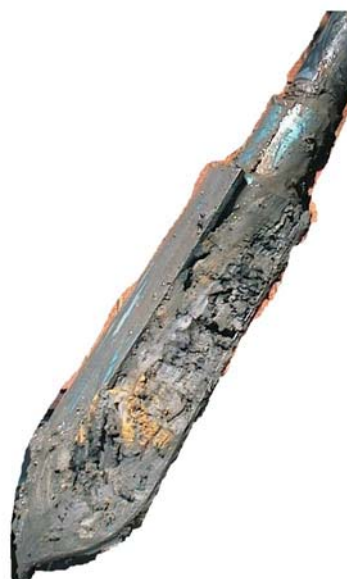
We have retrieved disturbed samples and tested them using both the filter paper soil suction technique and oedometer test. The solid red line - see right - is the oedometer and the suction test is the red broken red line.

By adjusting the K_0 line to a sensible position (with the suction plotted as the grey broken line) we see a close correlation between the two sets of readings.

Both record a maximum bulge at between 1 - 2mtrs bGL, reducing with depth.

The estimate of swell are in agreement. In BH1 they are around 60mm.

If there is a difference it is the fact we do not have to compensate for the K_0 line using the oedometer, whereas we do using the filter paper technique but disturbance doesn't seem to make a significant difference.

The estimates of heave do not correspond directly with the precise levels of course, because we have a persistent moisture deficit and the only way to verify if the estimate is correct would be to fell the tree!

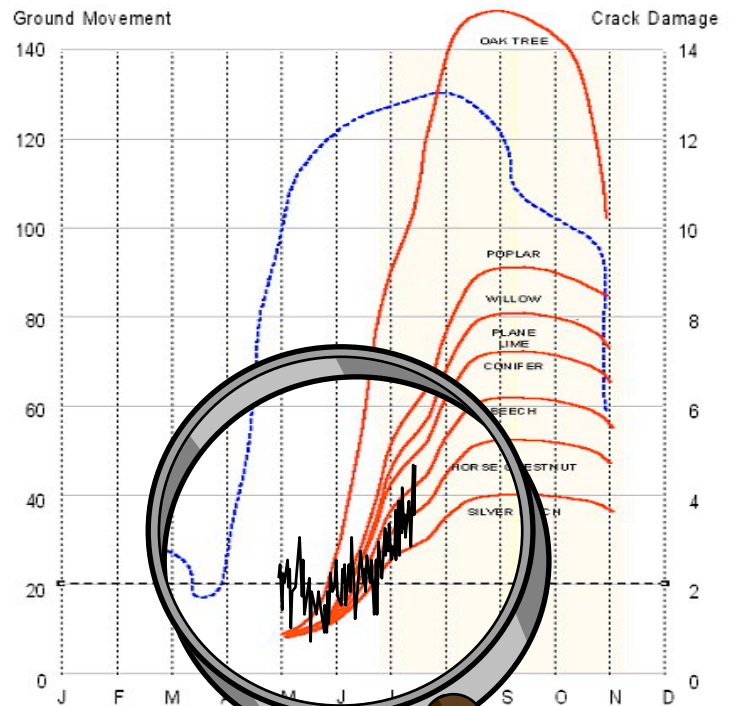
We are validating electrolevels on actual claims where we can correlate with precise level readings and understand the output. Below we see data from May through to July and it is following the characteristic curve of root induced seasonal movement.
